Manhole Inspection Summary

Manhole # S19CC2004MH

Location Address: **5602 BRYN MAWR**

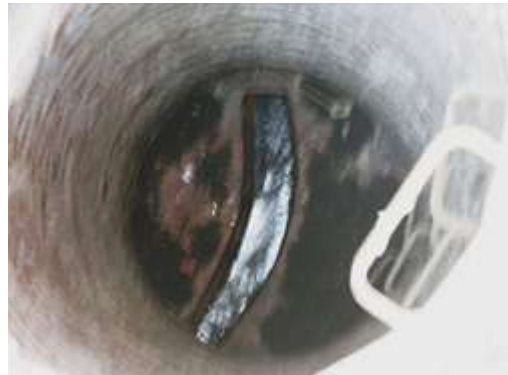
Top View

Bench ☒ Exists Material: **Brick** ☐ Parged ☒ **Debris** (not Condition related)

Surcharge ☒ **Evidence Of Surcharge** Depth: **1** (ft.) ☐ Active Surcharge Present

Evidence of surcharge - Bench debris.

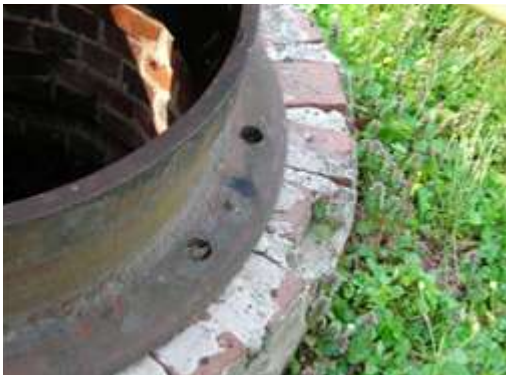
Defect

Loose frame - no bolts.

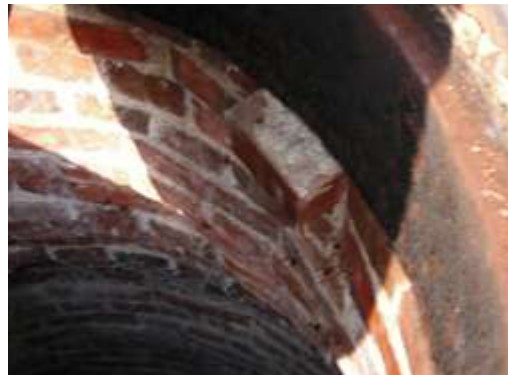
Defect

Frame Offset: **0** (in.) Condition: ☐ Sound ☐ Cracked ☒ **Leaks**

Condition: ☐ Sound ☐ Cracked ☐ Root Intrusion ☒ **Loose Brick** ☐ Deteriorated

Infiltration: ☐ None ☒ **Joint** ☐ Cracks ☒ **Mortar** ☐ Roots ☐ Wall

Frame leaks. Adjustment loose brick and infiltration.

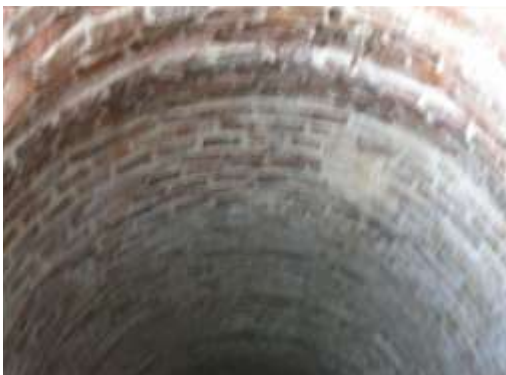
Defect

Adjustment infiltration.

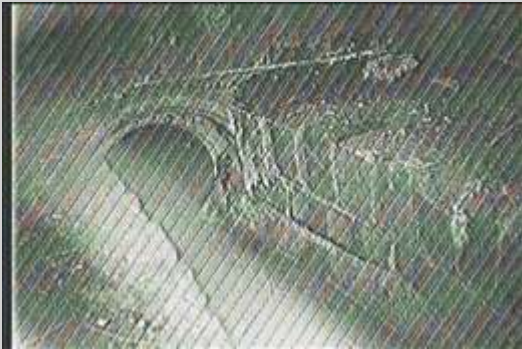
8 in. Circular Gravity Sewer Pipe Out @ 12 O'Clock

Comments **This MH is located near the soccer field. It is missing the frame bolts. The O12 pipe picture shows Channel deterioration.**

Condition: ☐ Sound ☐ Cracked ☐ Root Intrusion ☒ **Deteriorated** ☐ Leaks ☐ Debris

Infiltration: **Evidence** Pipe Seal Cond: **Unknown**
